ERNEST ORLANDO LAWRENCE BERKELEY NATIONAL LABORATORY

Duct Tape Durability Testing

M.H. Sherman and I.S. Walker

April 2004

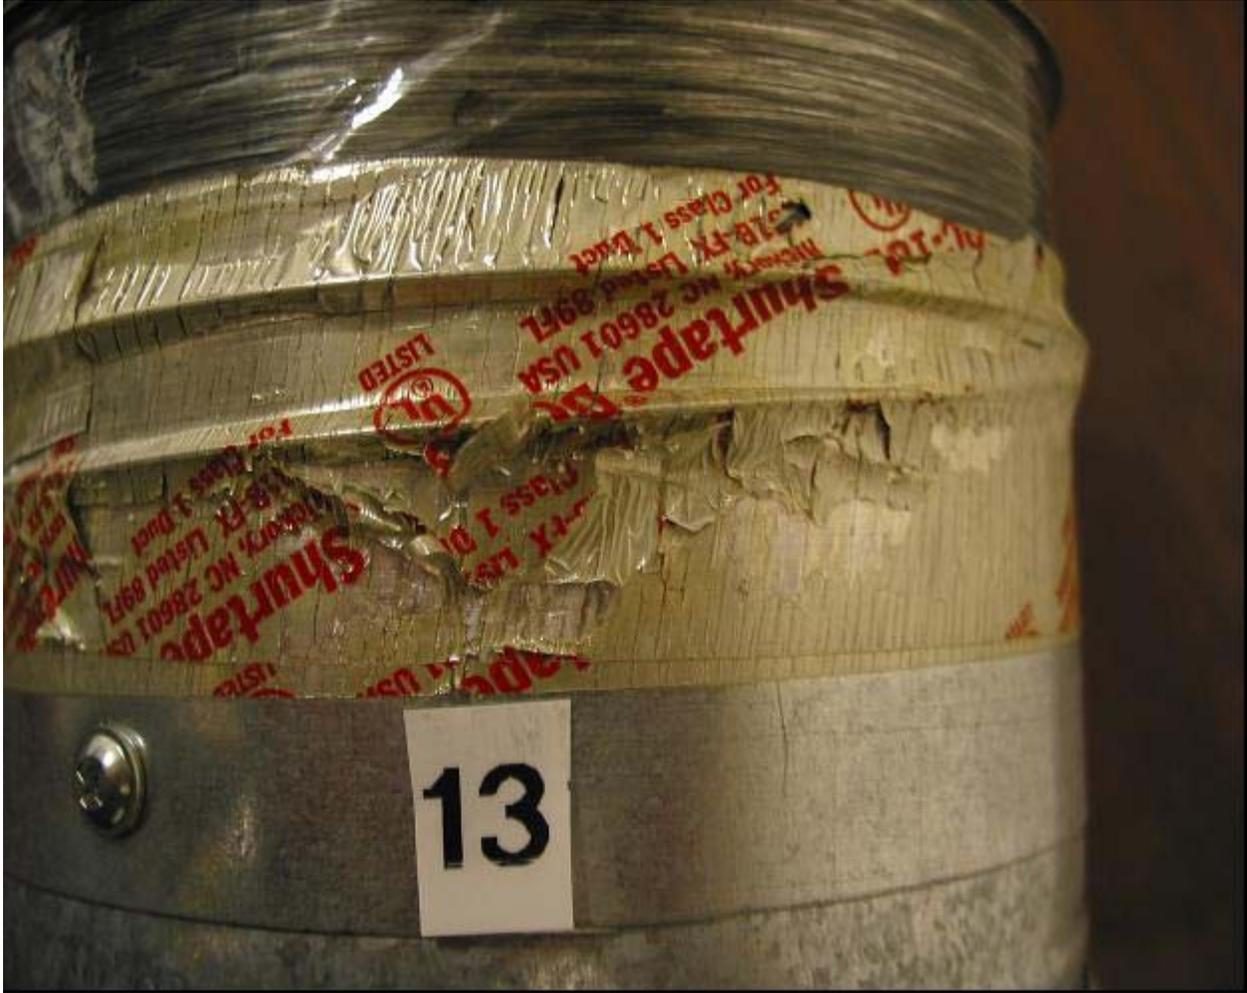
Figure A16. Sample 13. This sample is cracking and peeling.

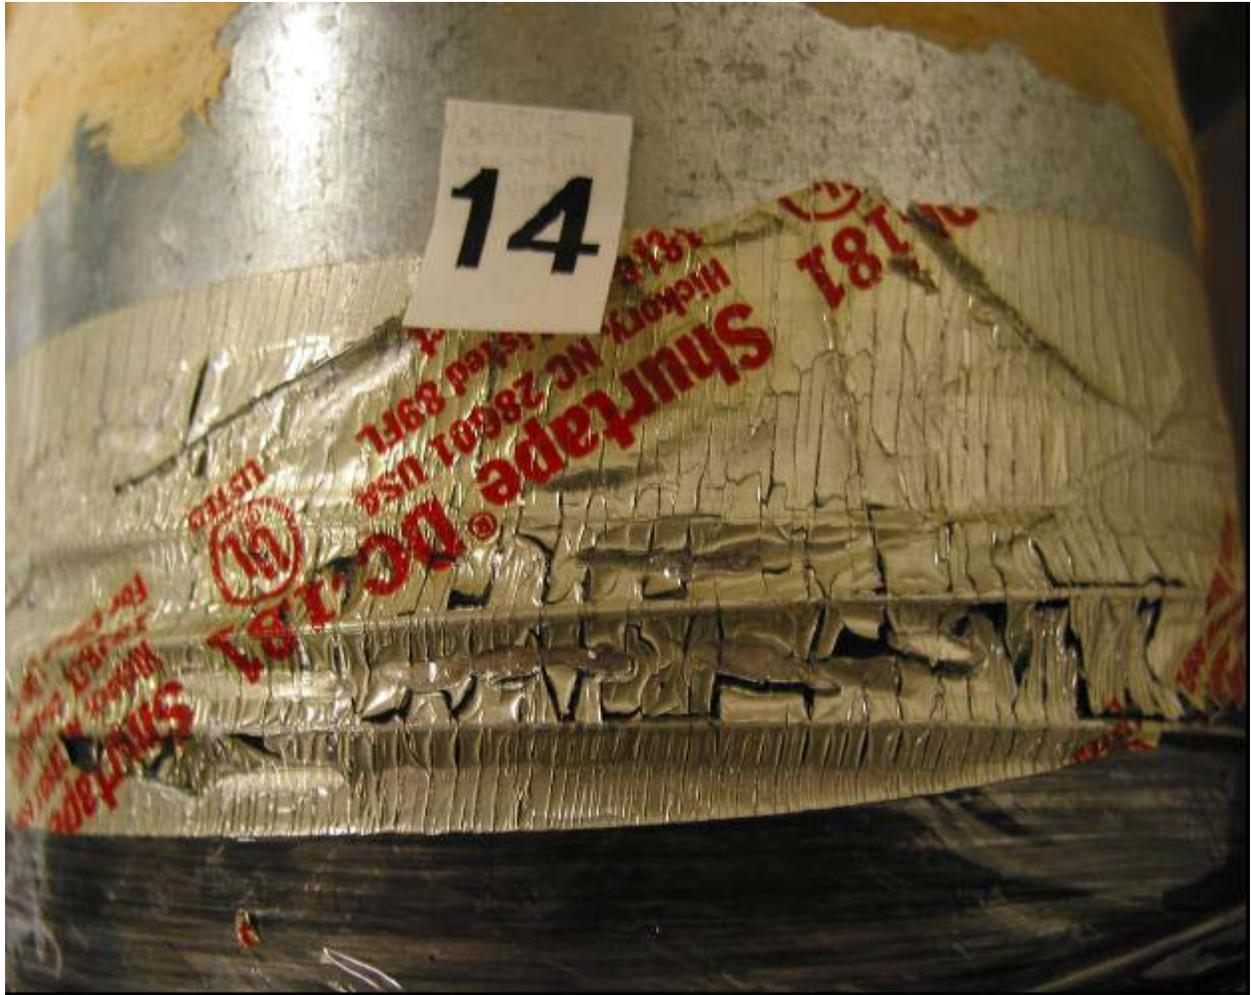
Figure A17. Sample 14. This sample shows the same cracking and splitting as Sample 13.

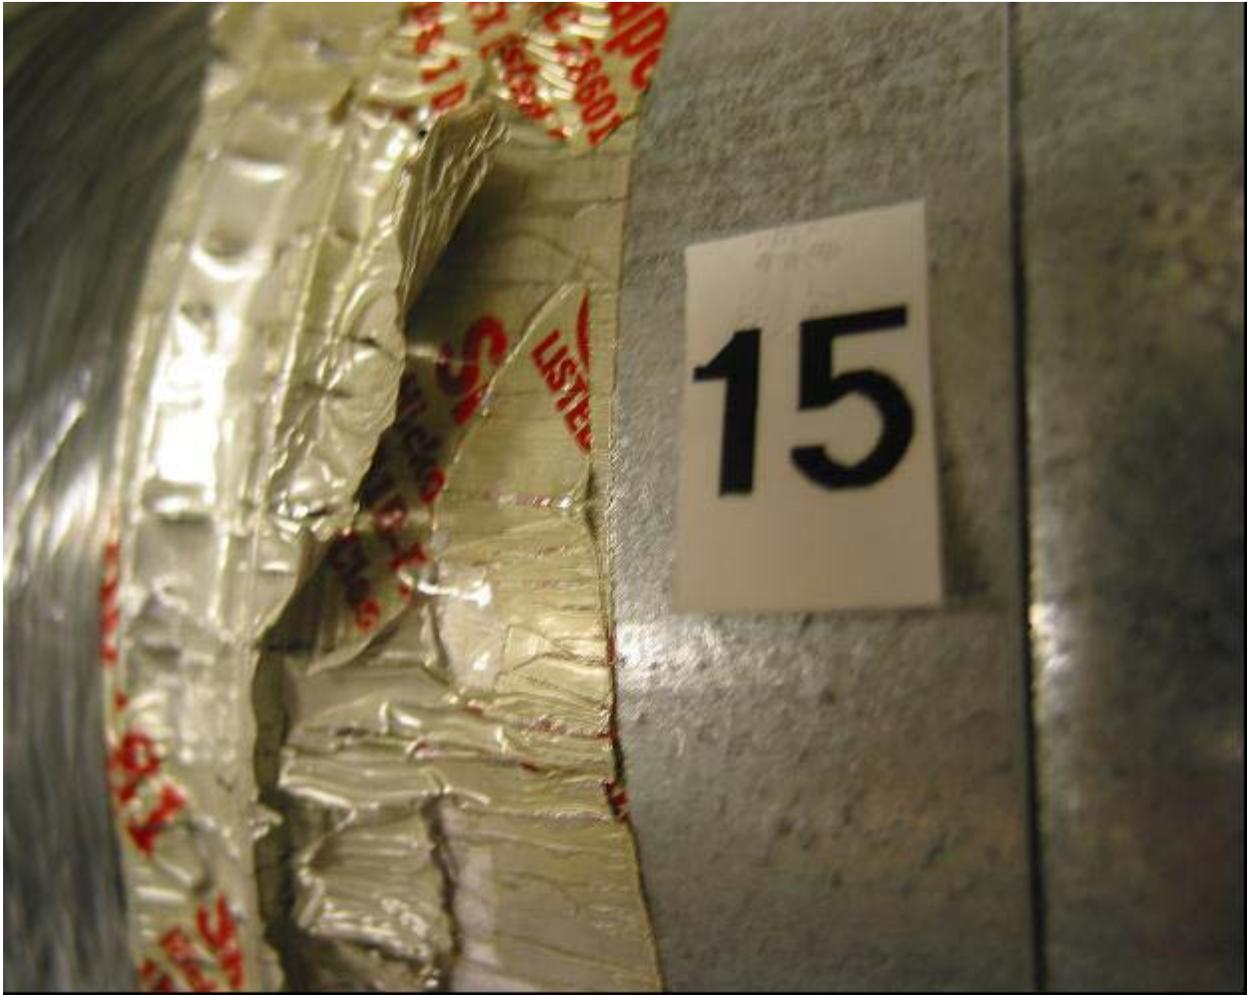
Figure A18. Sample 15. Like samples 13 and 14, this sample is also peeling and cracking. This figure shows how the metallized layer is splitting from the adhesive layer.

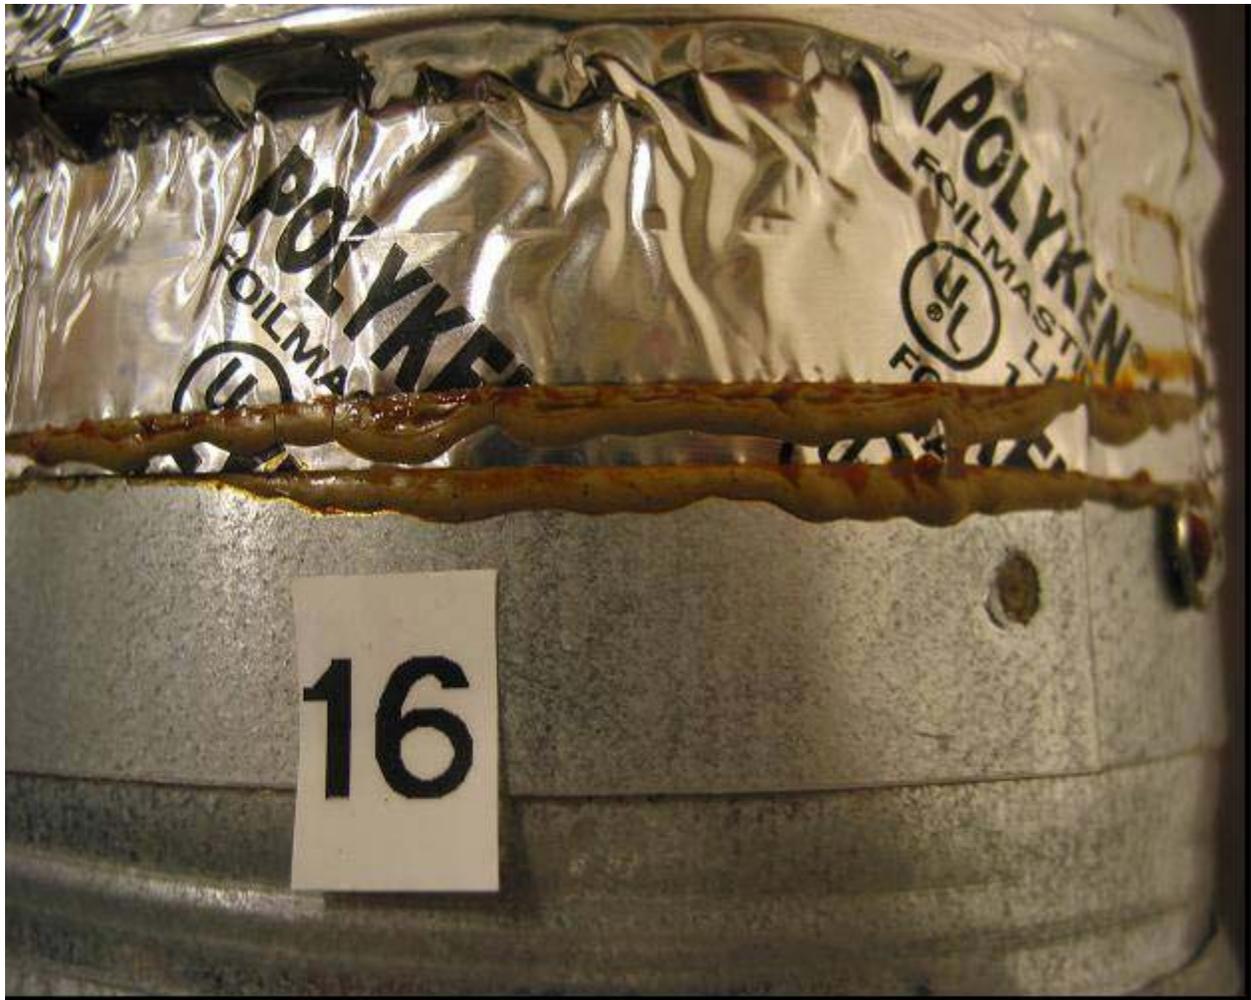
Figure A19. Sample 16. This sample shows oozing of the adhesive at the tape edges.

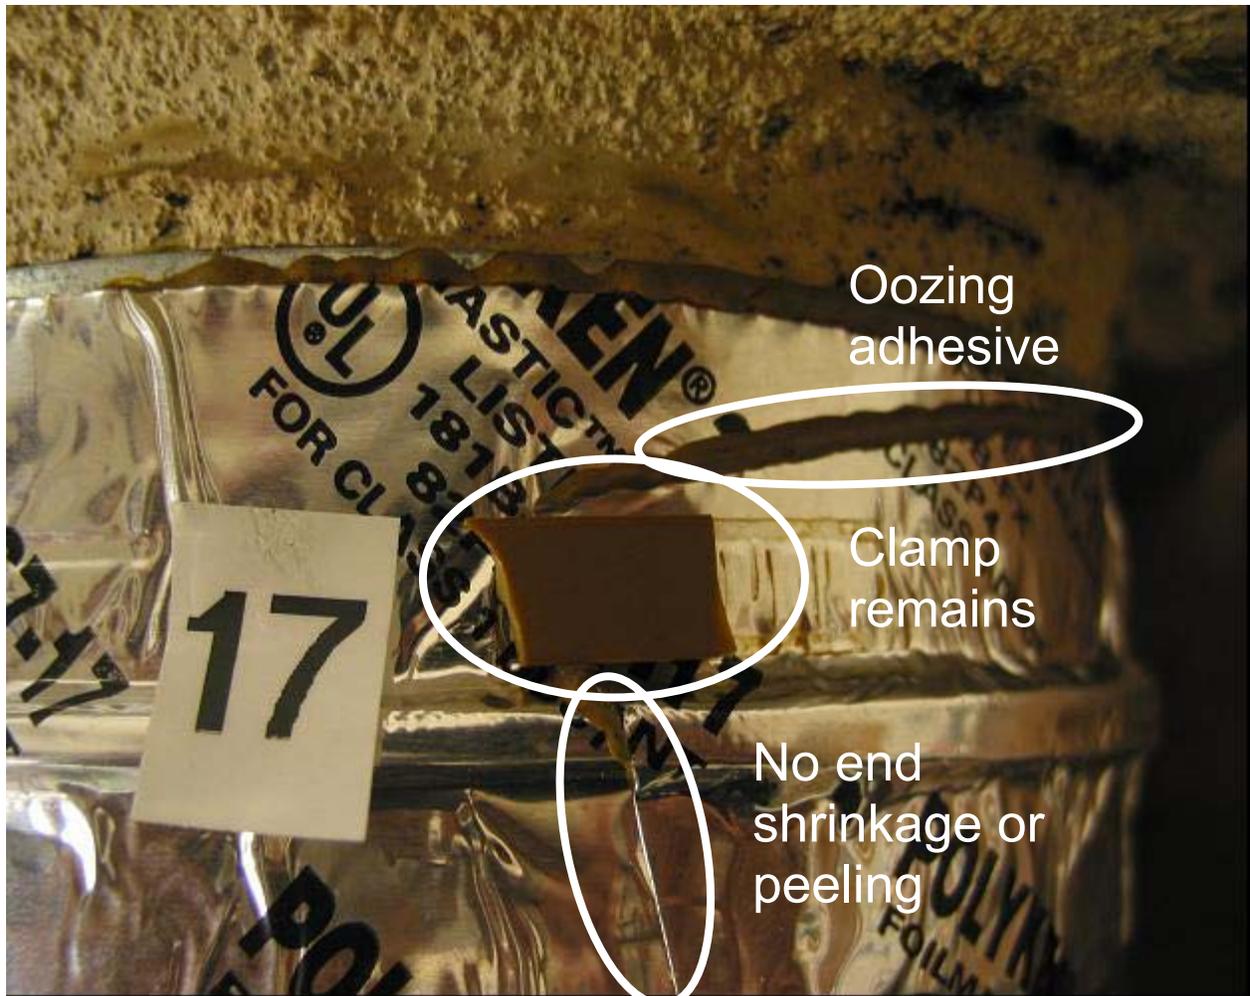
Figure A20. Sample 17. As with sample 16, this metal foil tape is showing oozing of the adhesive. Note that there is no shrinkage or delamination like the other tapes at the end of the tape. There is also a small piece of clamp stuck in place by the oozed adhesive.
